NAVAL FACILITIES ENGINEERING SERVICE CENTER
Port Hueneme, California 93043-4328

Technical Report TR-2040-OCN

FDS-D WET-END SURVIVABILITY POST TEST ANALYSIS

March 1995

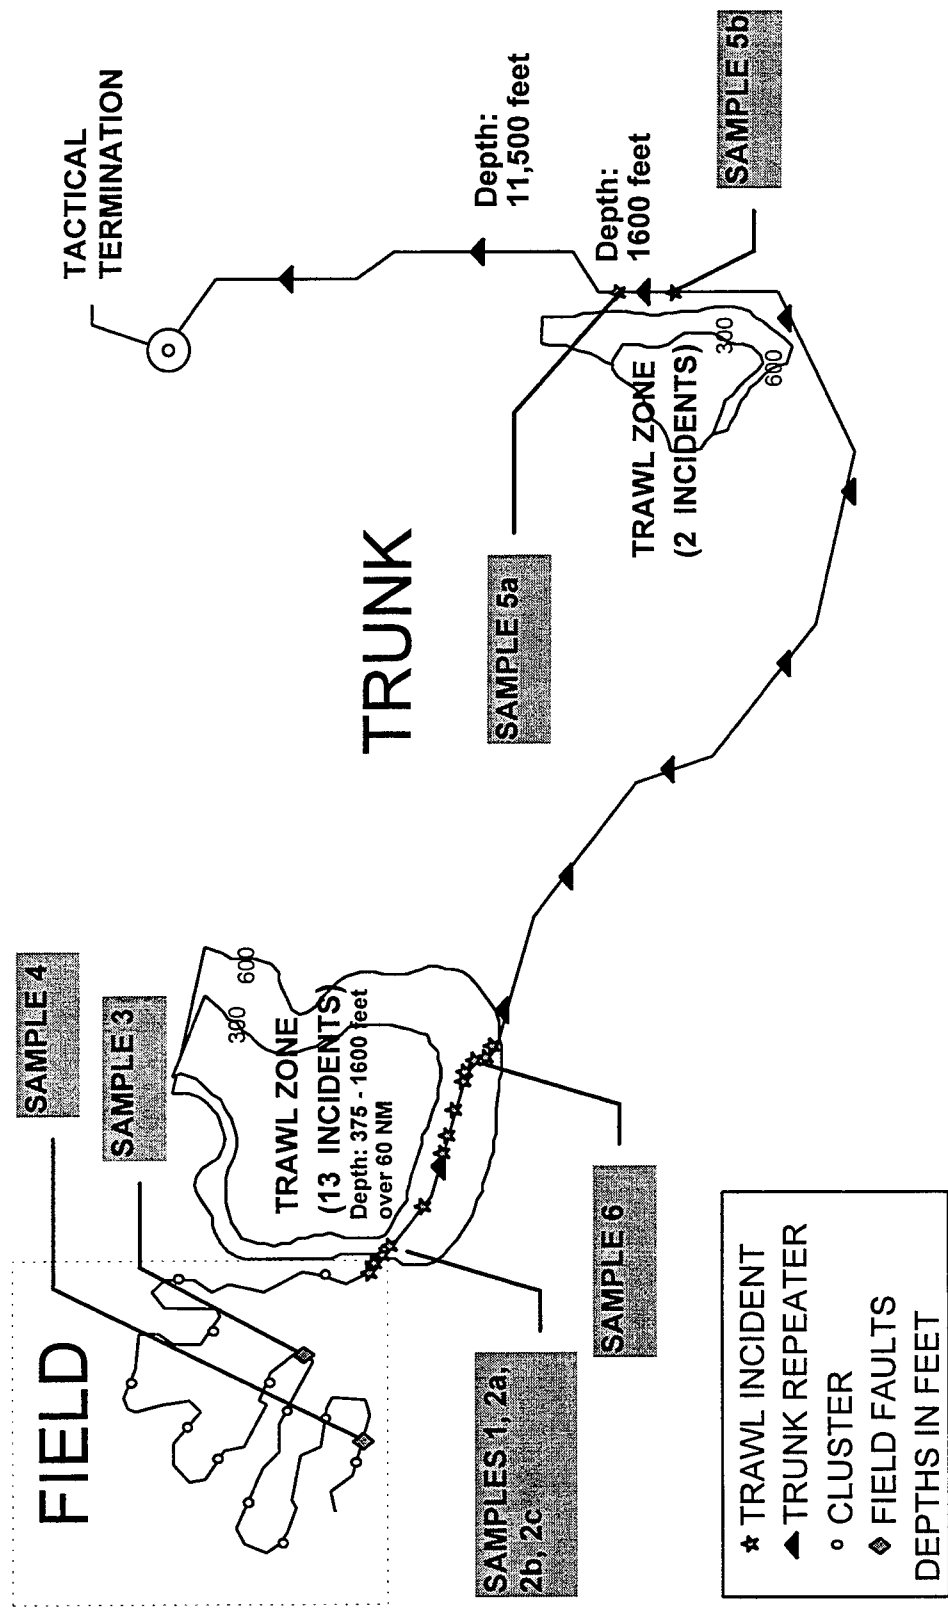
FIGURE A-1. FDS-D UWS

Fault Sample	Electrical Failure?	Optical Failure?	Near Bitter End?	Improve with armor?
1	no	no	no	yes
2a	yes	no	no	yes
2b	yes	no	no	yes
2c	yes	no	no	yes
5a	yes	yes	yes	no
5b	yes	yes	yes	no
6	yes	yes	no	no

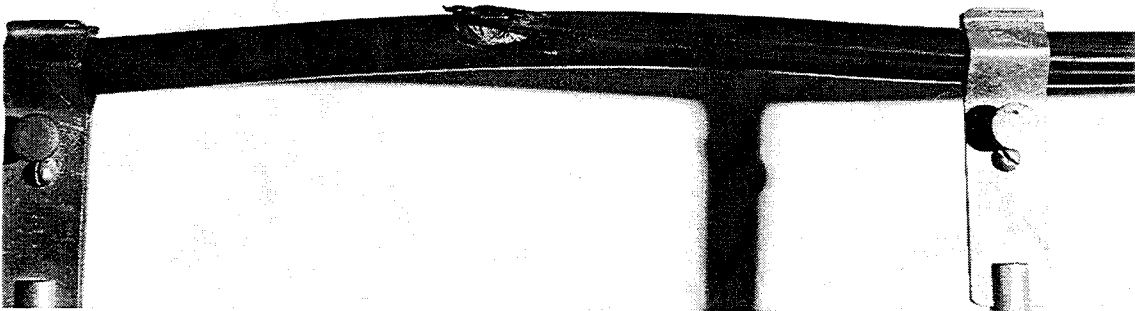
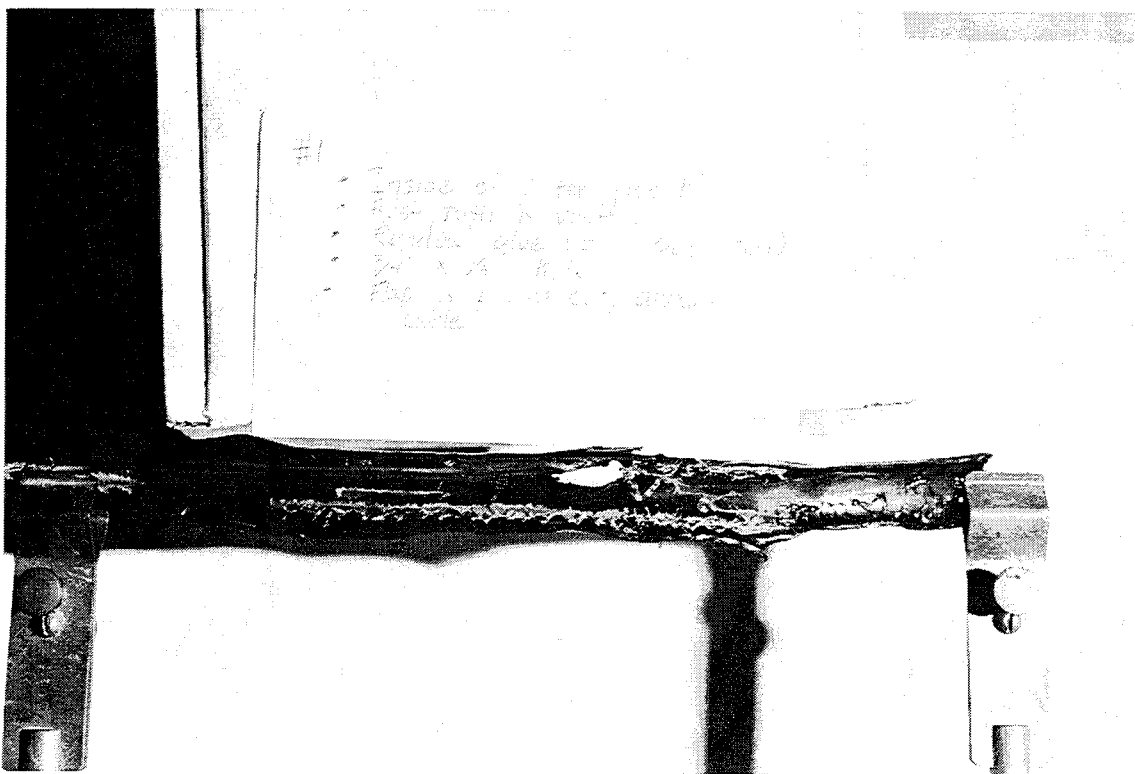
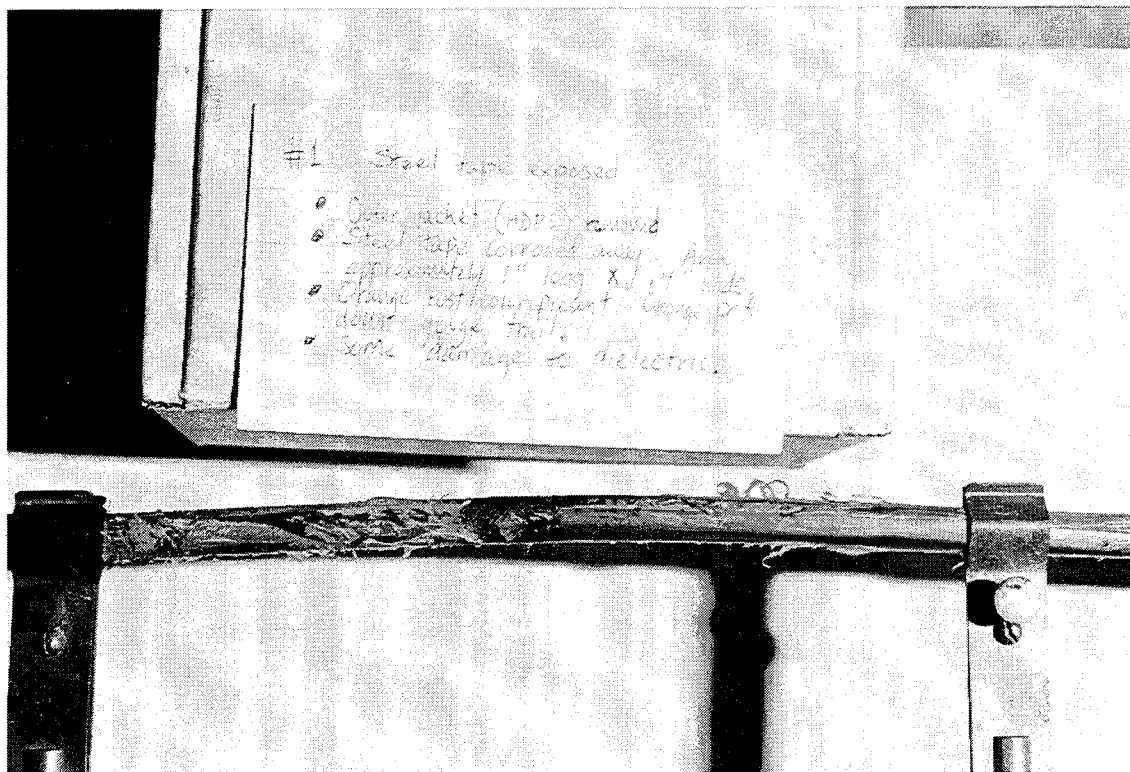
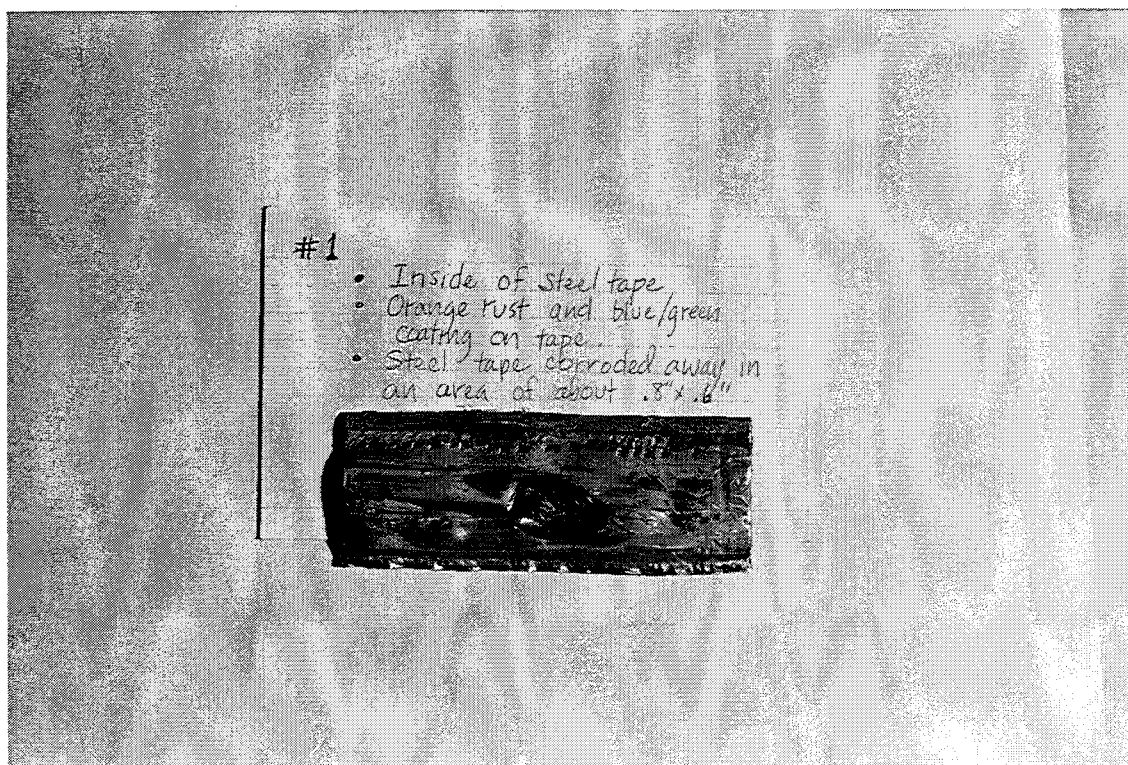
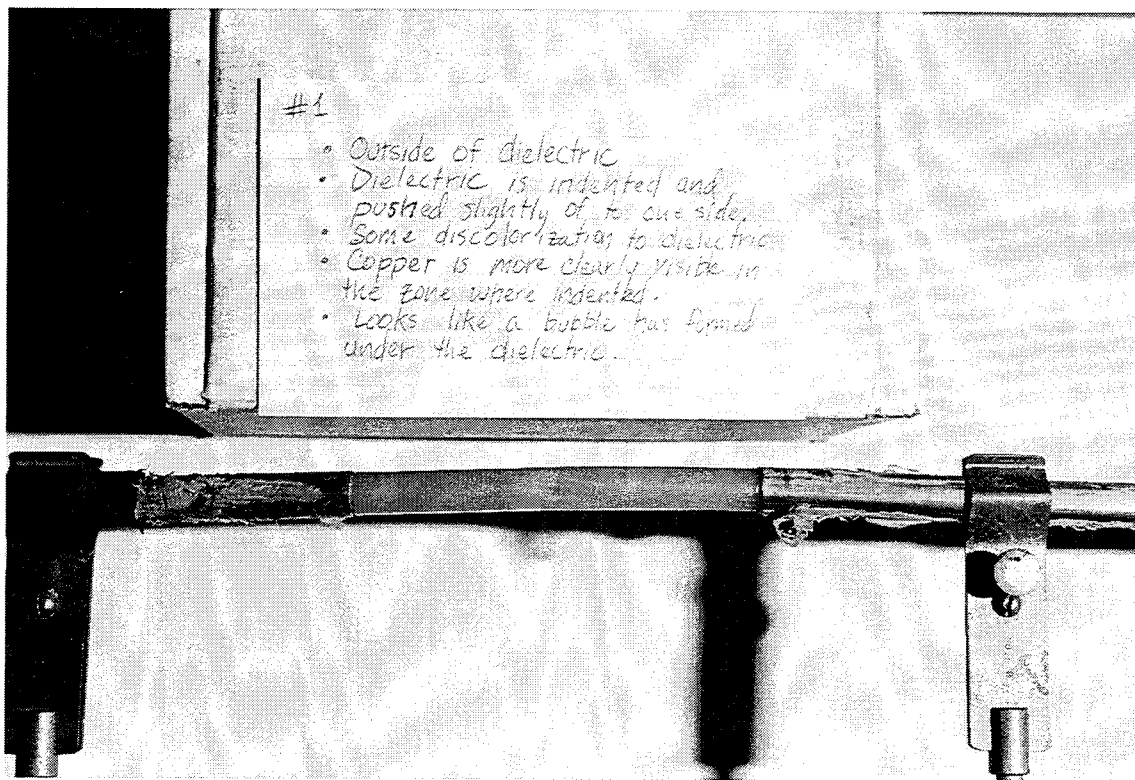
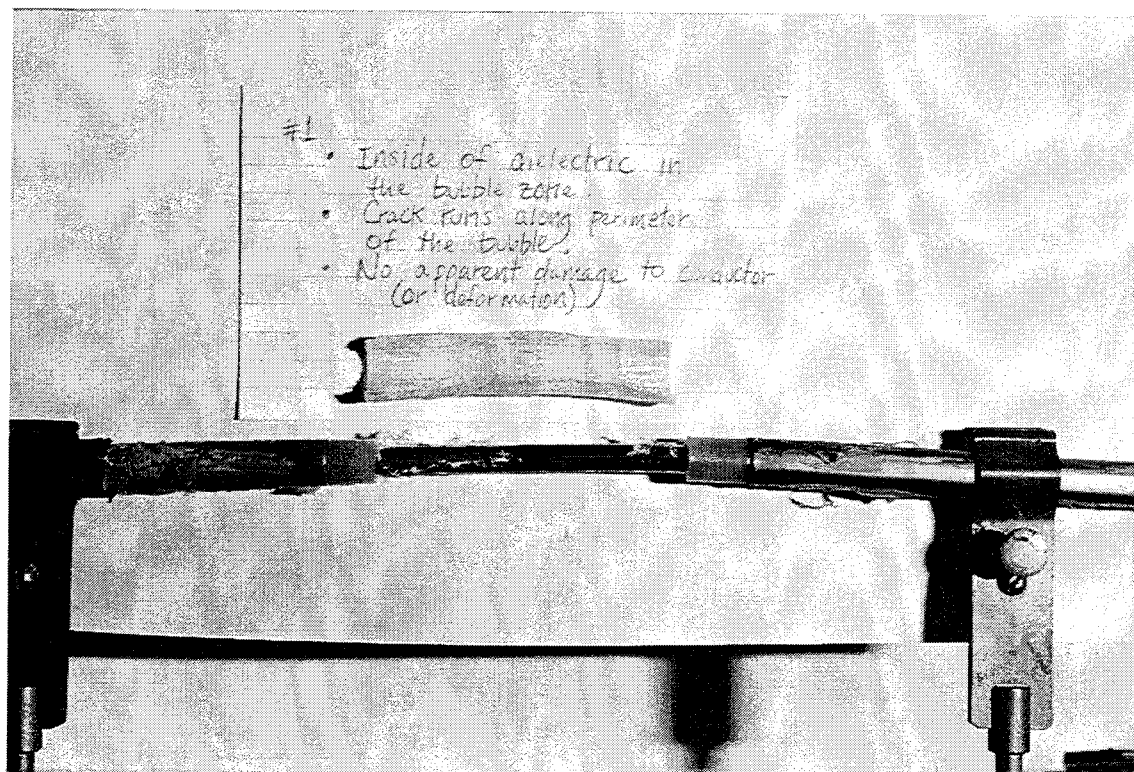
FAULT NO.	DATE RECOVERED/ LOCATION	DESCRIPTION
1	Recovered: 7/2/94 by T-ship Location: 1100' Depth, Appr. 5 nm shoreward of CL116.	Suspected trawl damage. Damage is a single cut in cable (0.6" x 0.4") down to steel tape. Minor groove in cable leading up to cut from one side. Green glue is visible on outside of tape. No sign of further penetration. Possible electrical failure.
2a,b,c	Recovered: 7/2/94 by T-ship Location: 1100' Depth, 4-5 nm seaward of CL116.	Suspected trawl damage. All three samples recovered within 4000' of each other with minor damage (nicks and grooves) between major damage. (2a) Deep gash down to strength member. (2b) Cut in outer jacket exposing tape. (2c) Deep groove along cable, long section where shield is exposed and green coating on outside of shield is present, one area where shield is penetrated and pushed open exposing the dielectric. Bottom: Along slope leading from bank (300-600') down to trench (1100-2000'). Electrical failure.

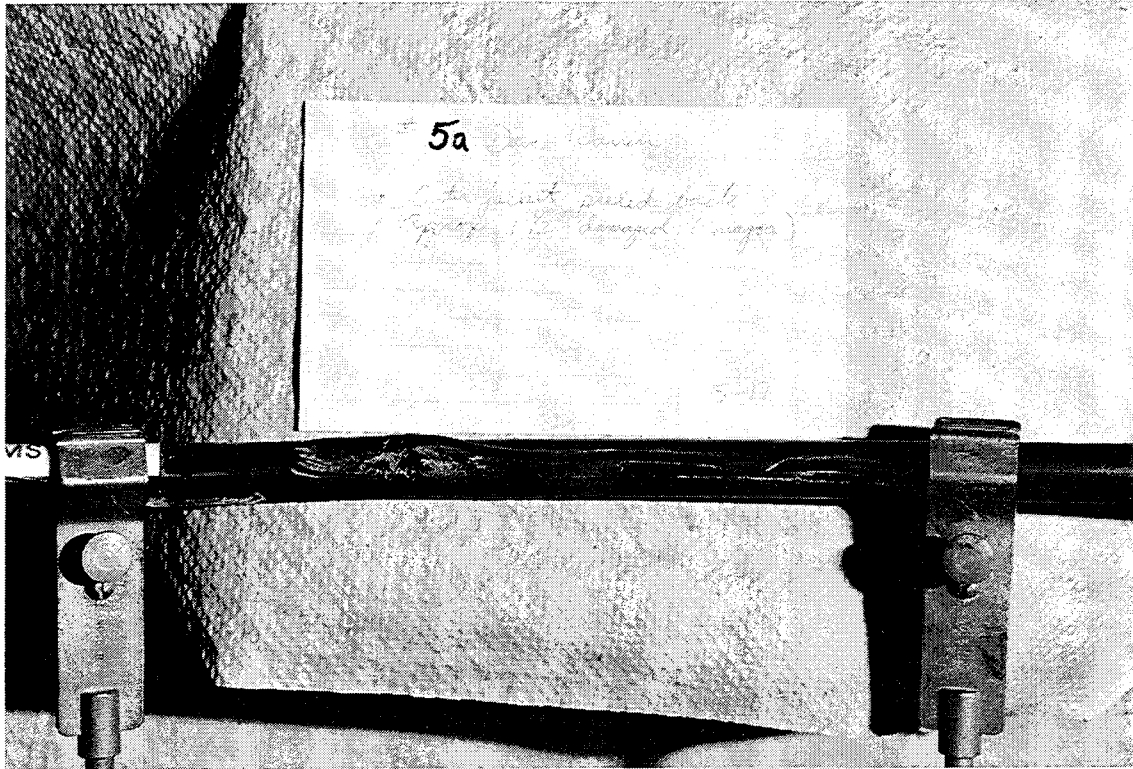
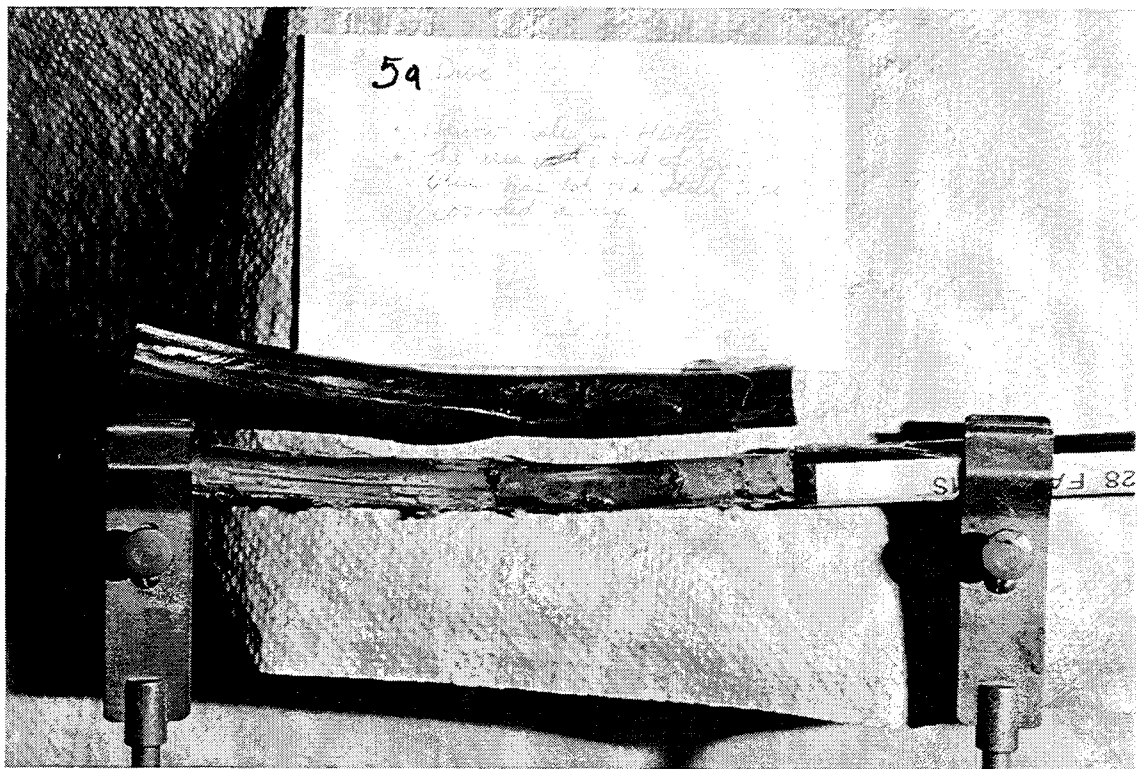
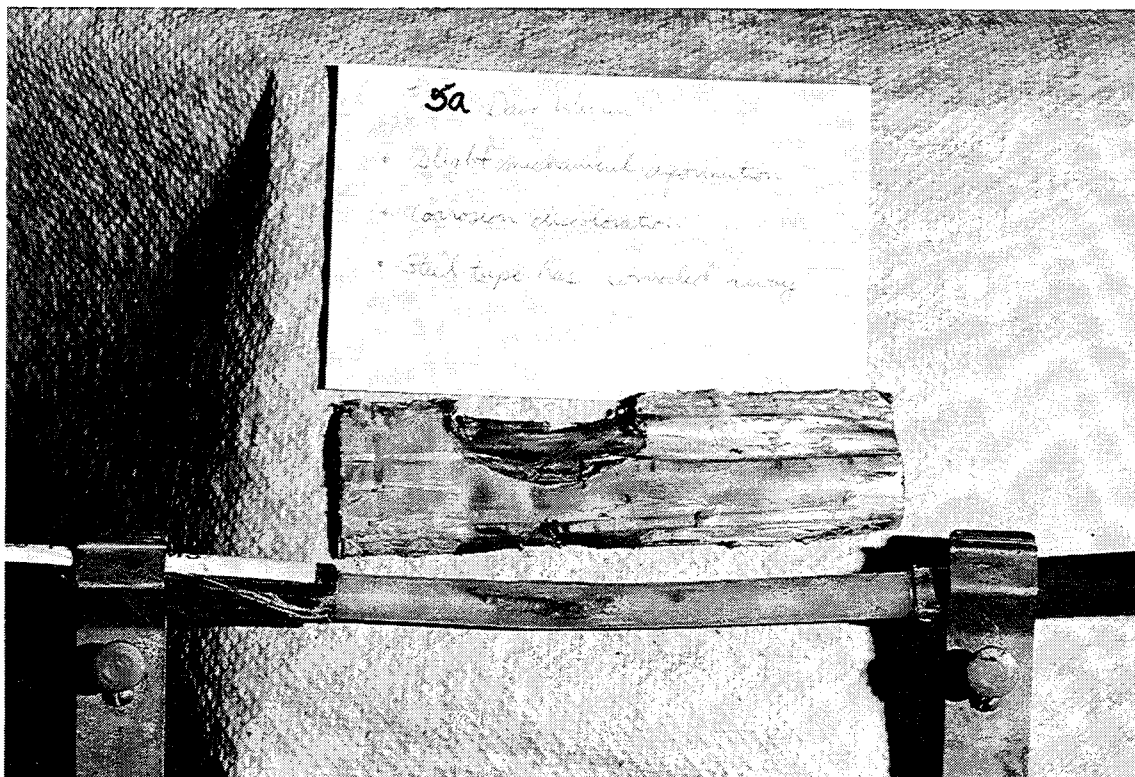
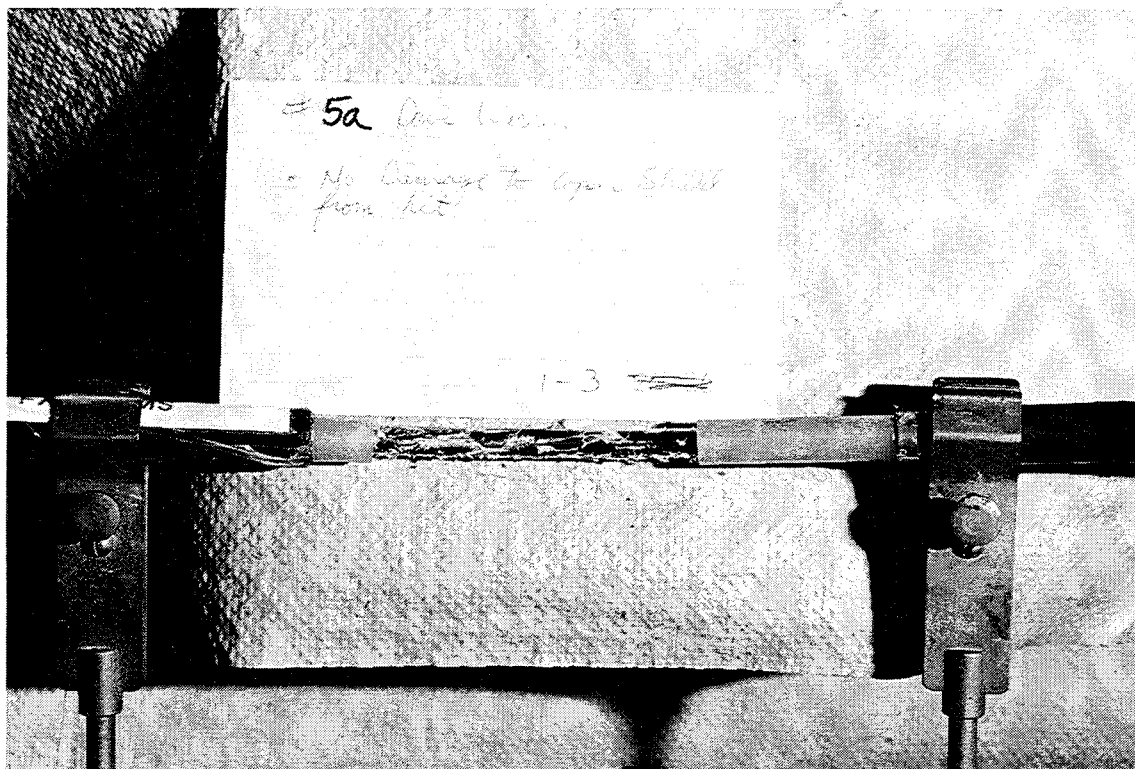
5.6 Fault Number 5a - FDS-D CABLE AUTOPSY WORKSHEET

Condition of Fiber: Performed a power meter check with one splice and one pare fiber adapter. The fiber checked out good.

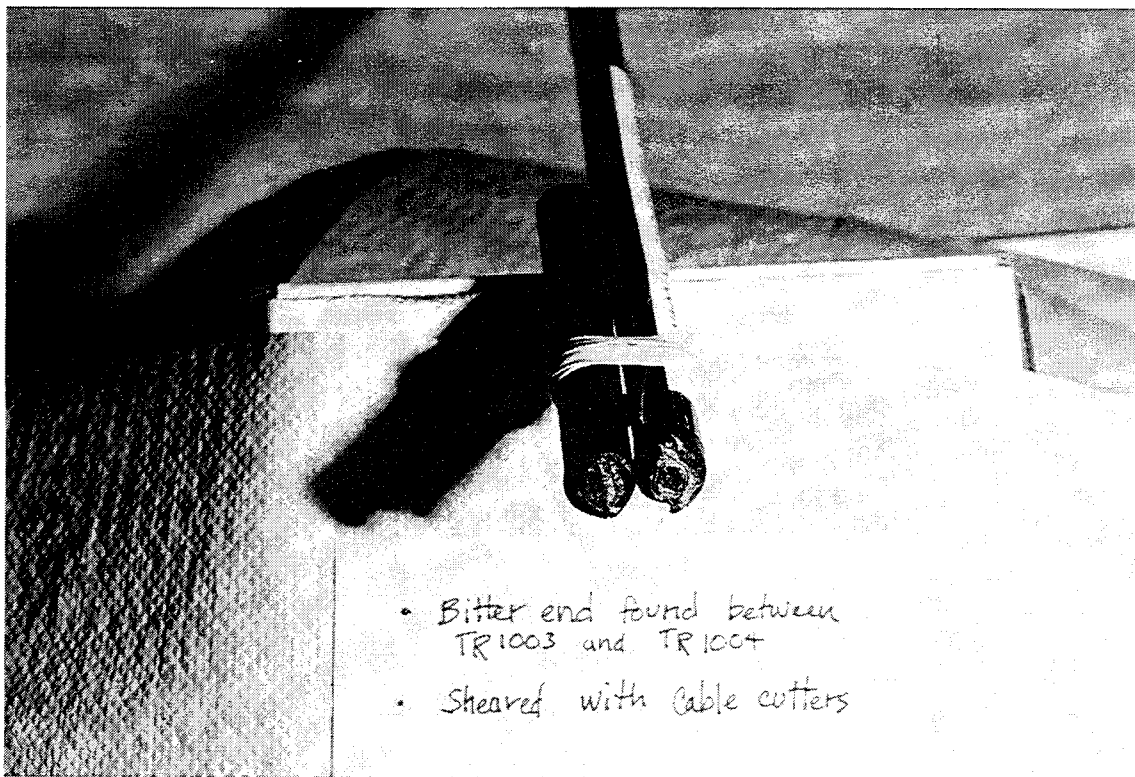
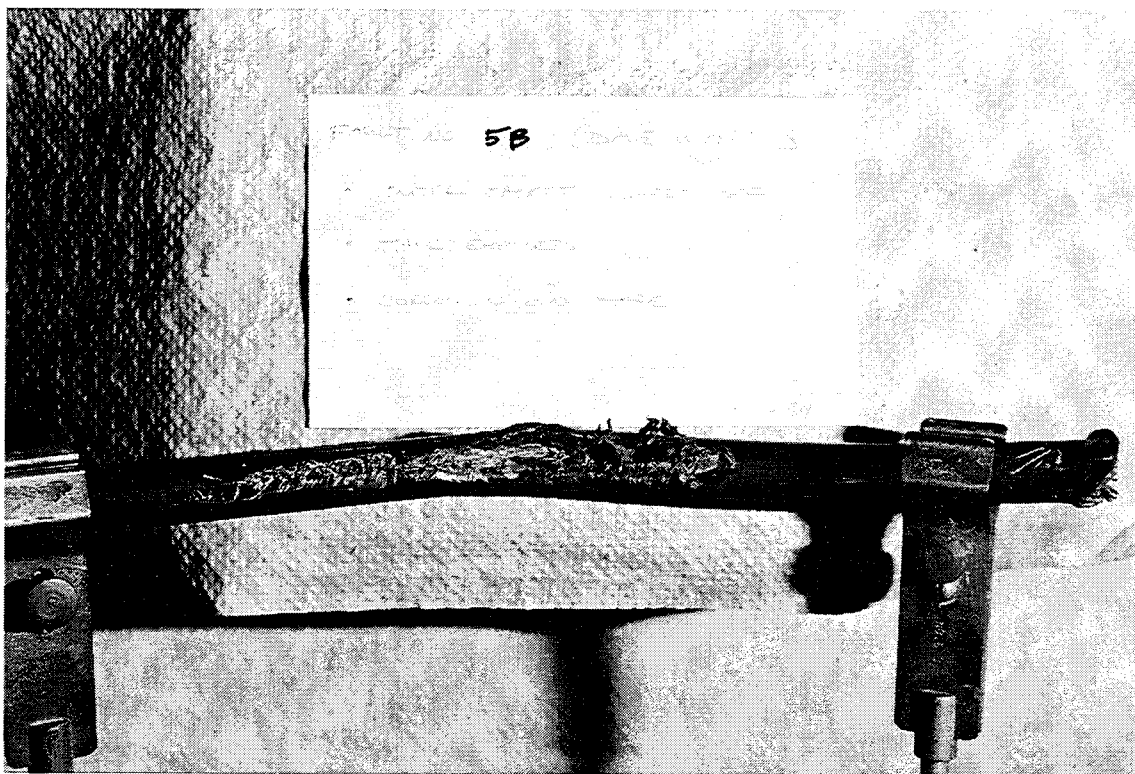
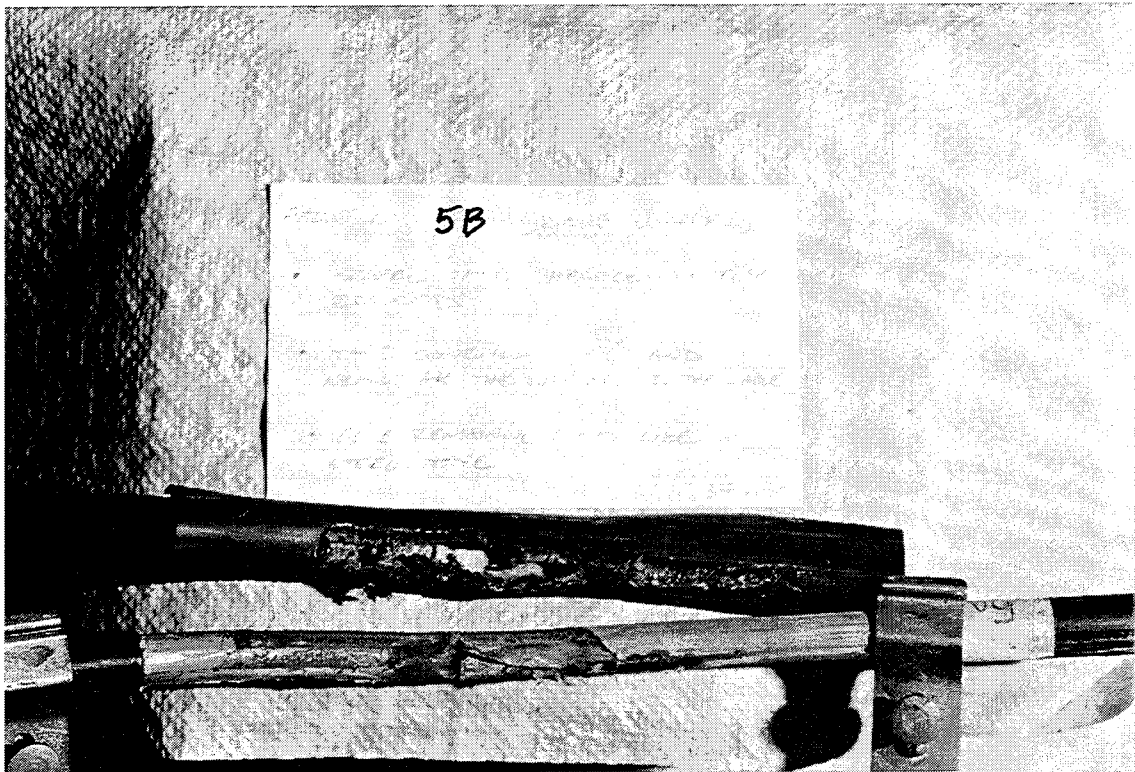
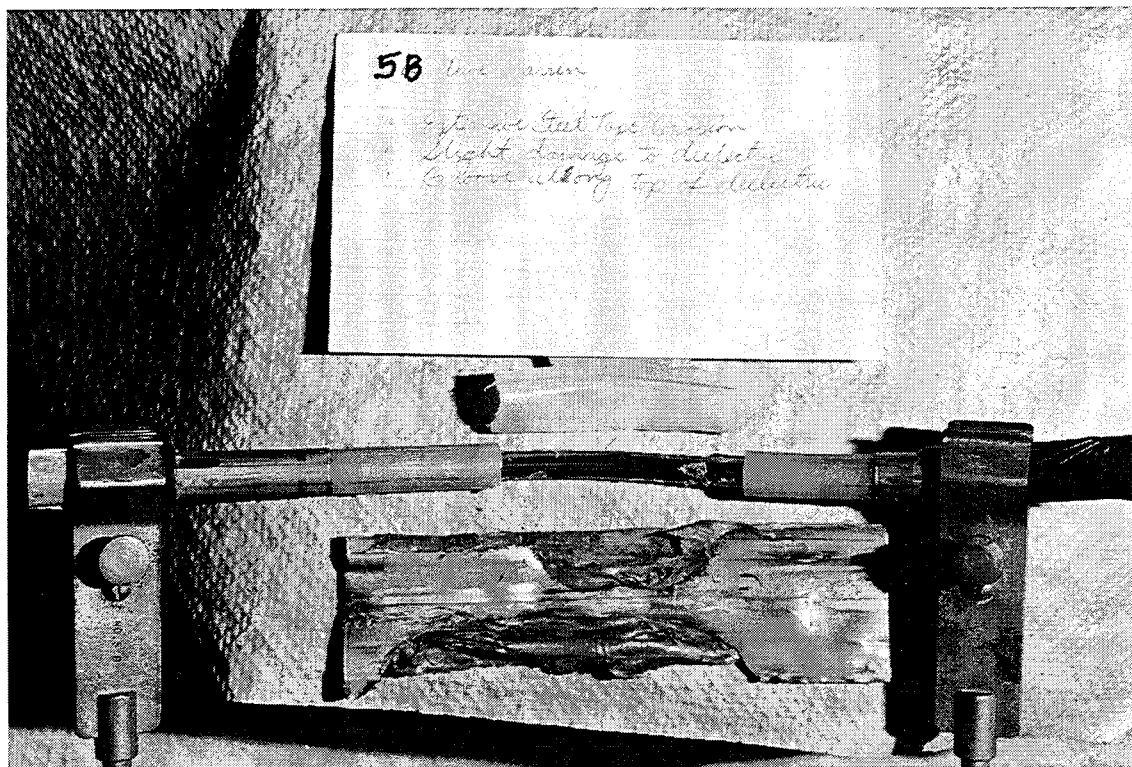
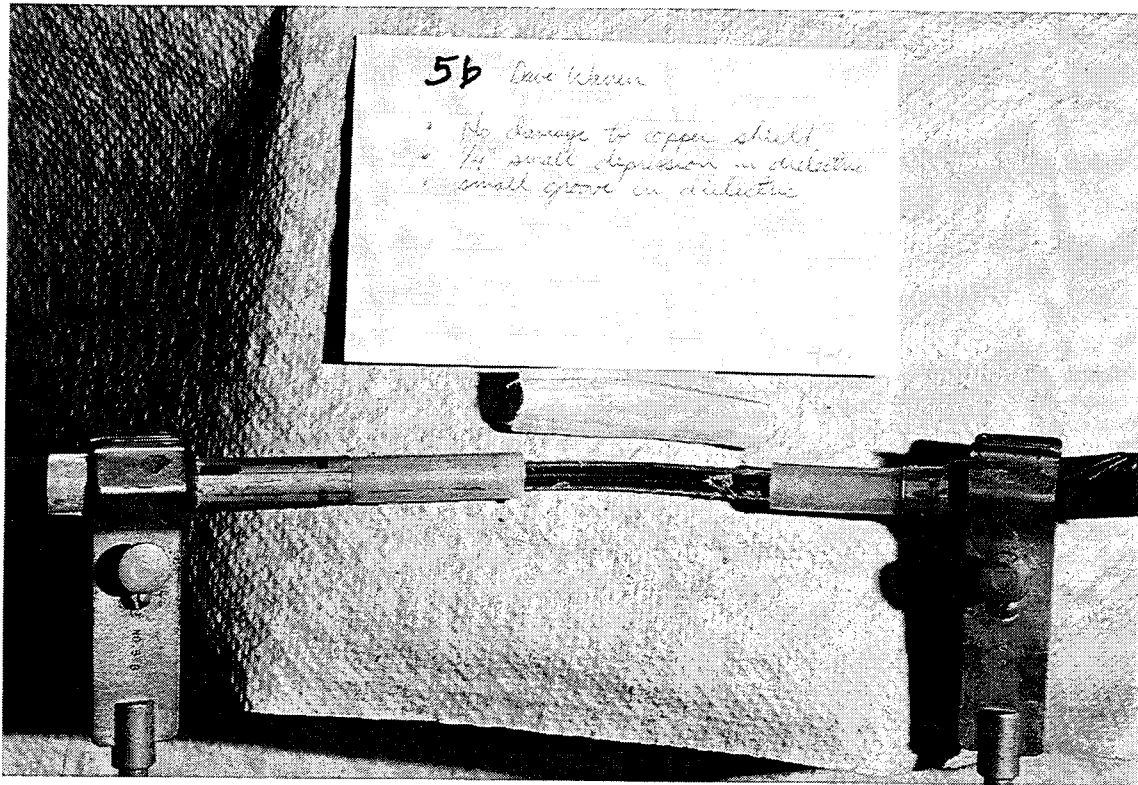
5.7 Fault Number 5b - FDS-D CABLE AUTOPSY WORKSHEET

Date Recovered: 8/ /94 Date Autopsied: 10/20/94
Autopsy Personnel: Carl Stevens, Steve Smuck
Date of Failure: Between 271200Z Jun 94 and 071400Z Aug 94
Location: 1.2 NM seaward of TR1004
Depth: 290 fathoms
Seafloor: Soft mud.

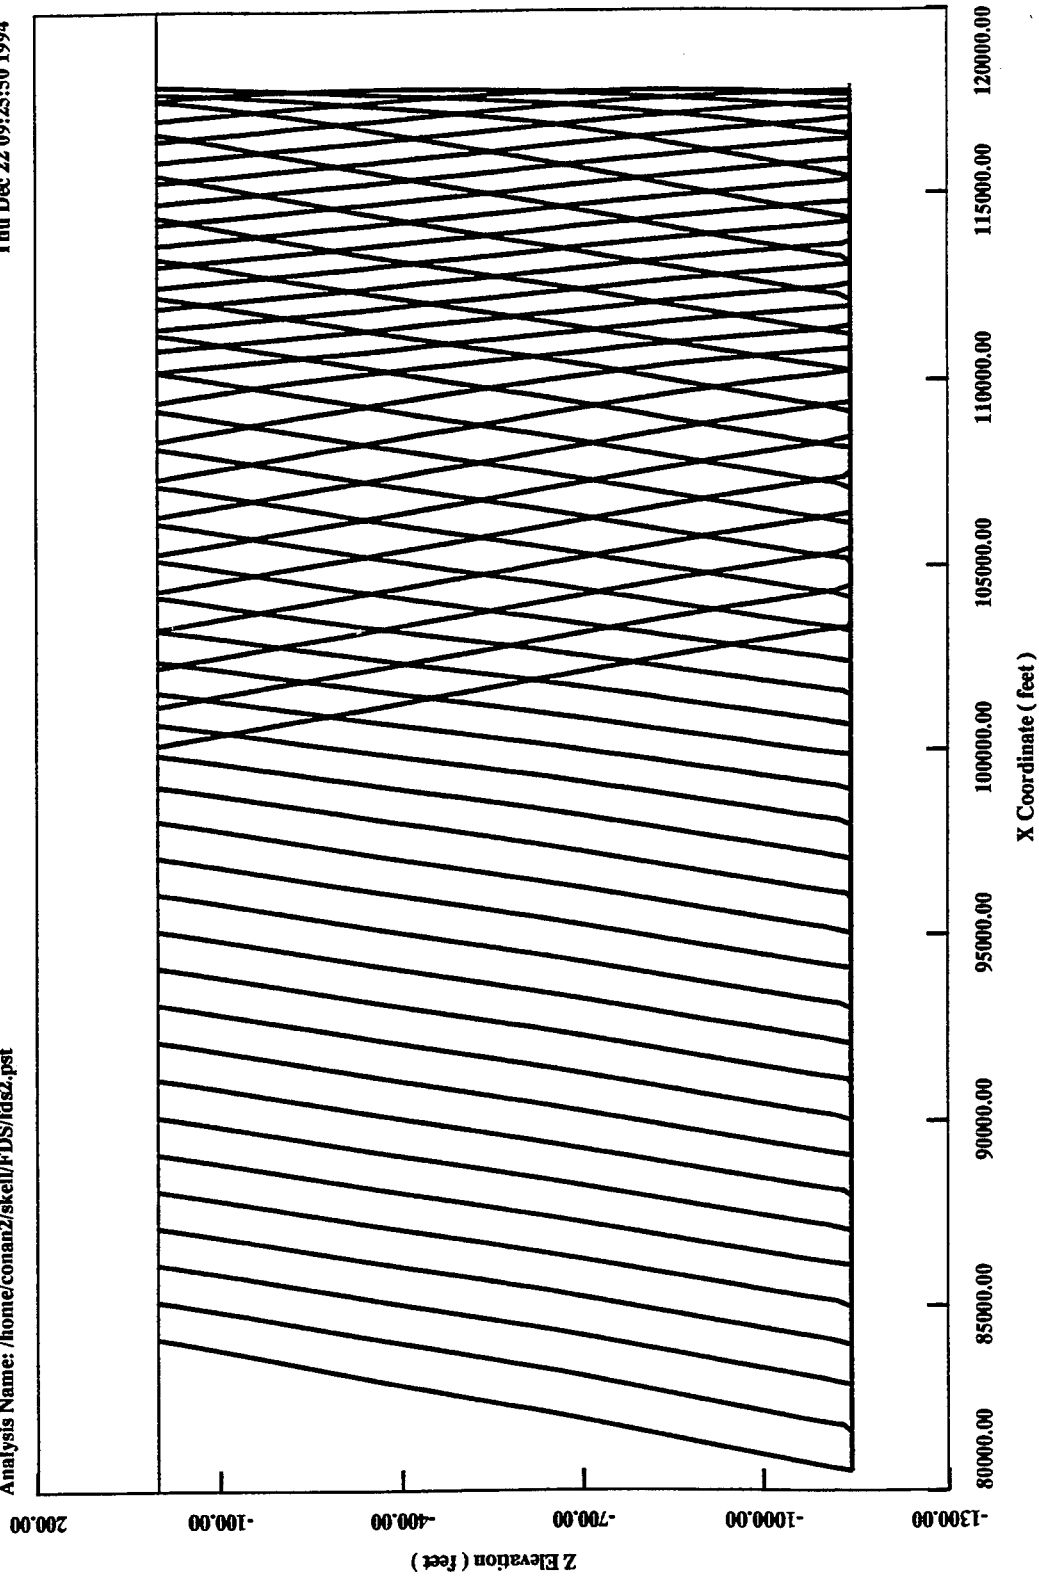
FIGURE 5. Plan View of Analysis 3. Snapshots of Deployed Cable at 200 sec Increments.
